[back to Inside a 71bug TOC](#)

[back to Inside a 63 Type 1 bug TOC](#)

Inside the 63 Type 1 tunnel

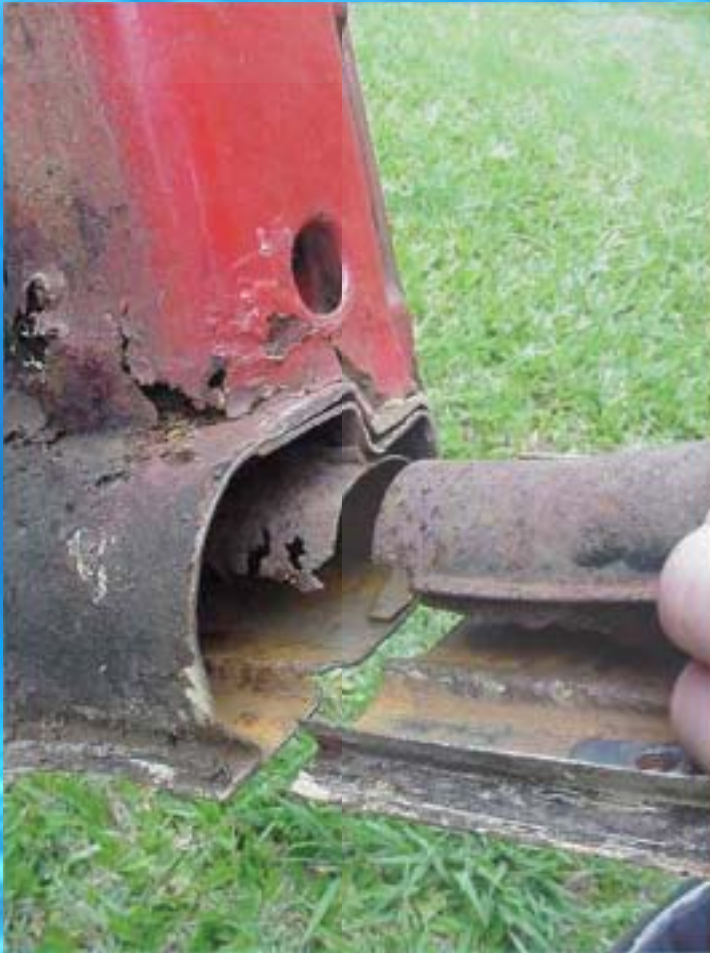
The "A" pillar (this photo is repeated from the previous section for continuity)

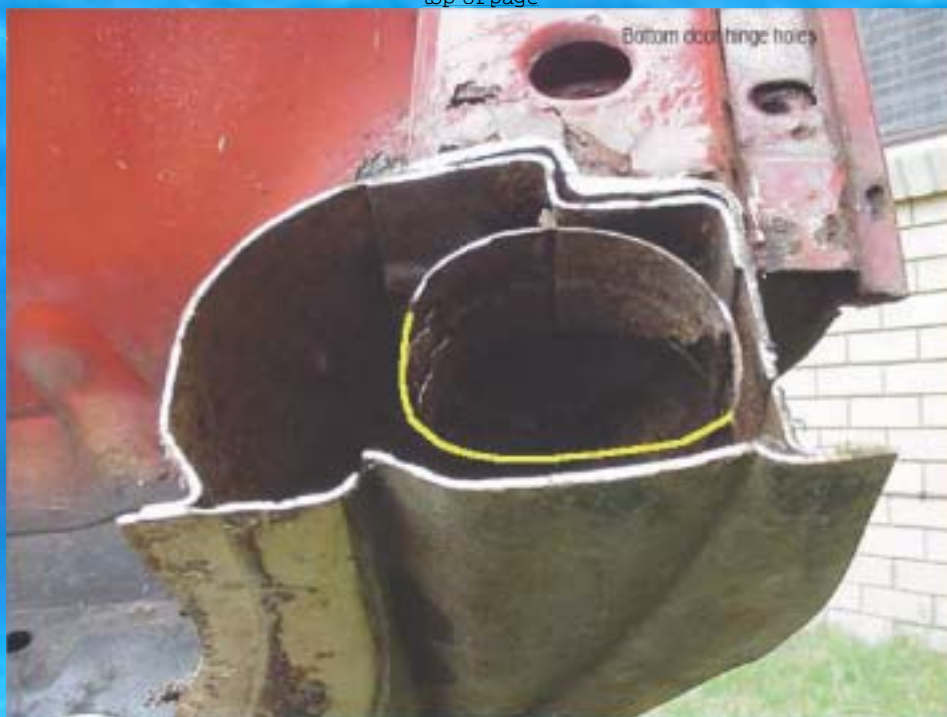
The right hand heater channel where it meets the "A" pillar. The heater duct at this point is socketed into each other (I did not cut the duct at this point). The top of the heater channel on the right of this photo has been removed to expose the heater duct inside
top of page

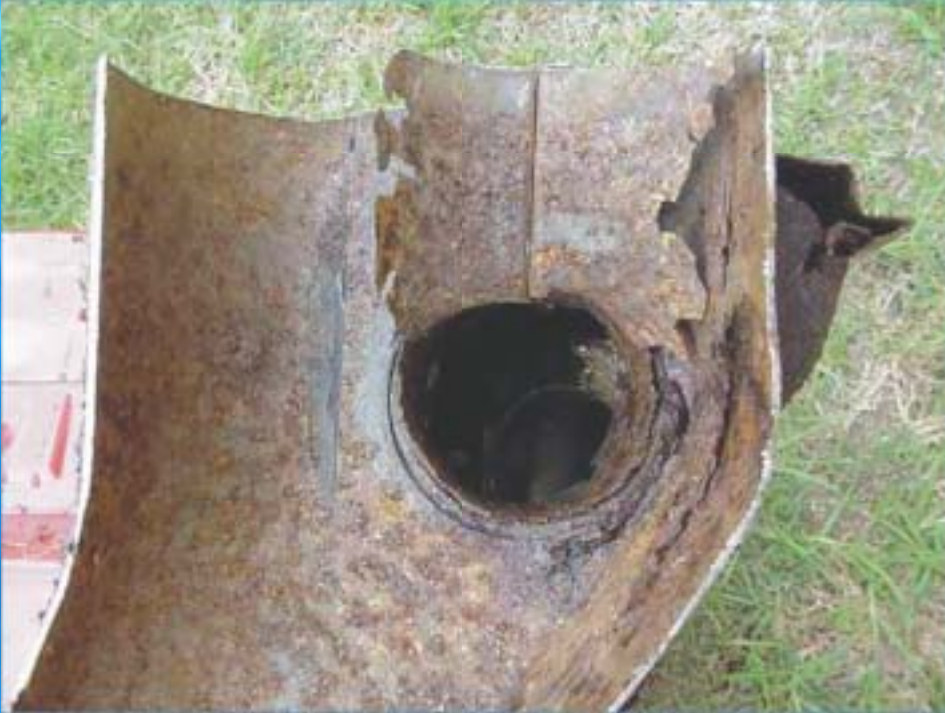
The right hand heater channel where it meets the "A" pillar. The yellow line indicates where I think the heater duct should be. The duct turns at this point, to rise into the "A" pillar.
[top of page](#)

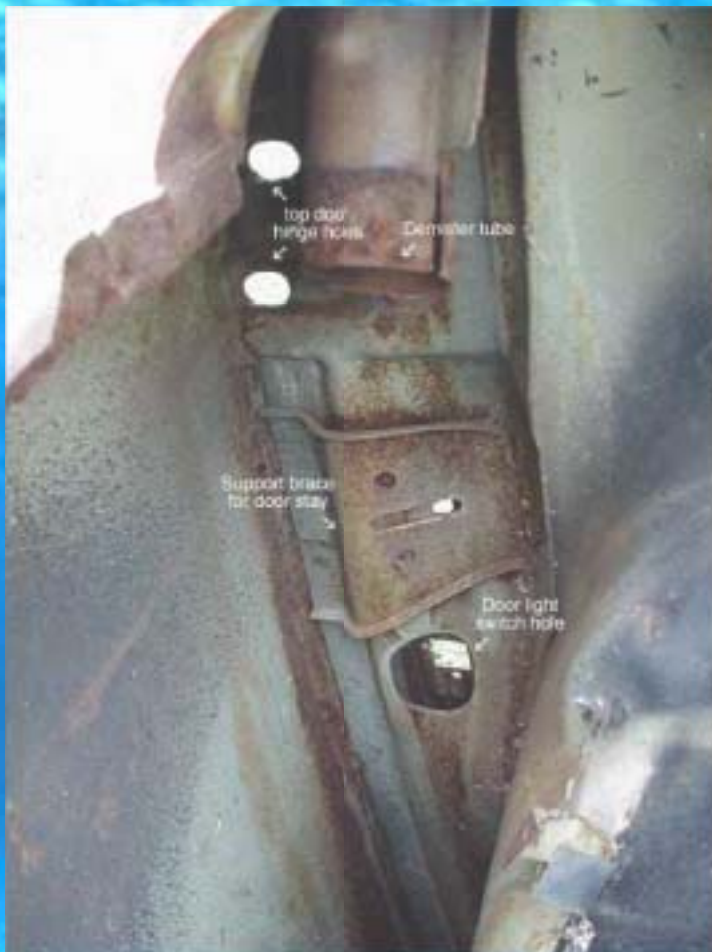
Looking up into the right hand "A" pillar after the bottom removed. This is the where the duct turns and rises into the "A" pillar.
[top of page](#)

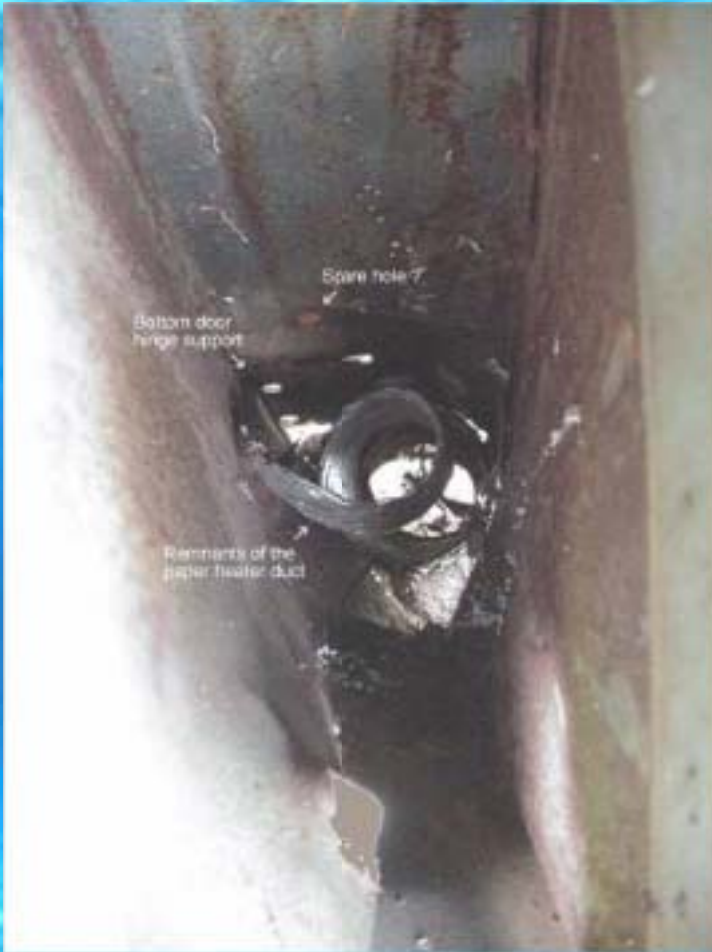
Now looking down into the right hand "A" from the top.
[top of page](#)

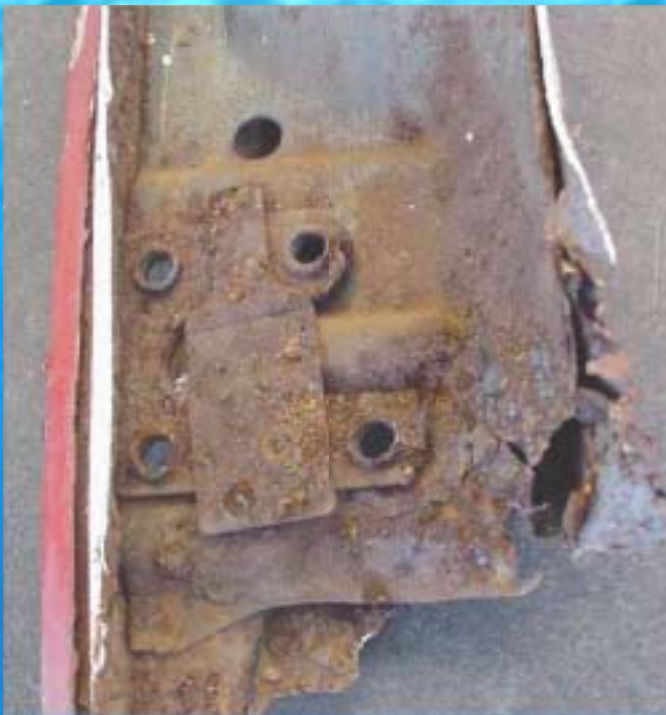
Looking further down into the right hand "A" pillar from the top.
[top of page](#)

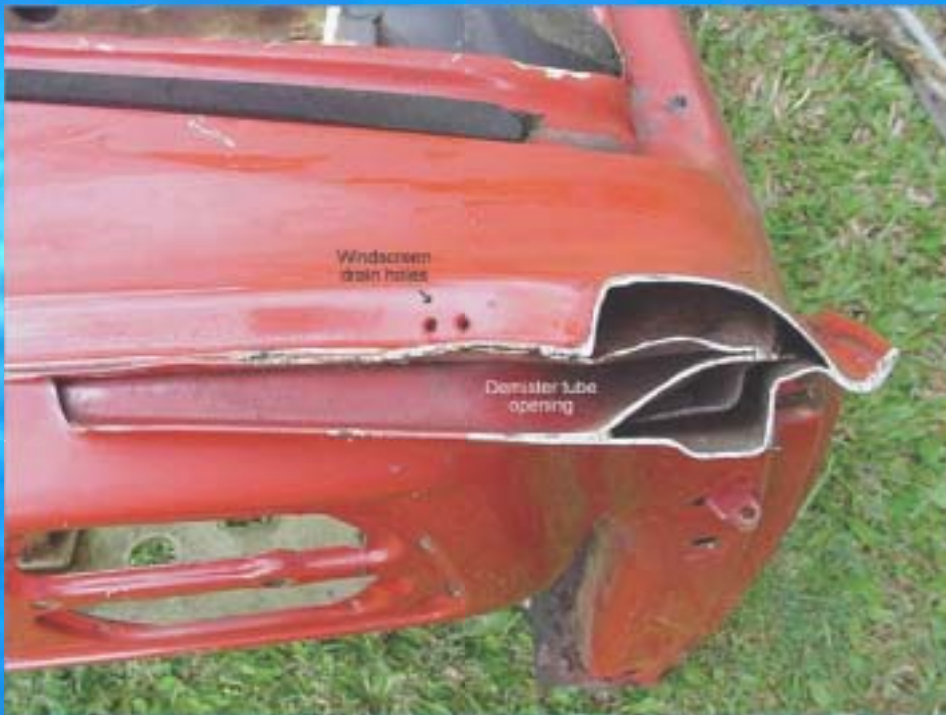
Inside the bottom of the "A" pillar. The heater duct as it rises from the heater channel. The edge at the bottom right of the photo is the inside of the front wheel well.
[top of page](#)

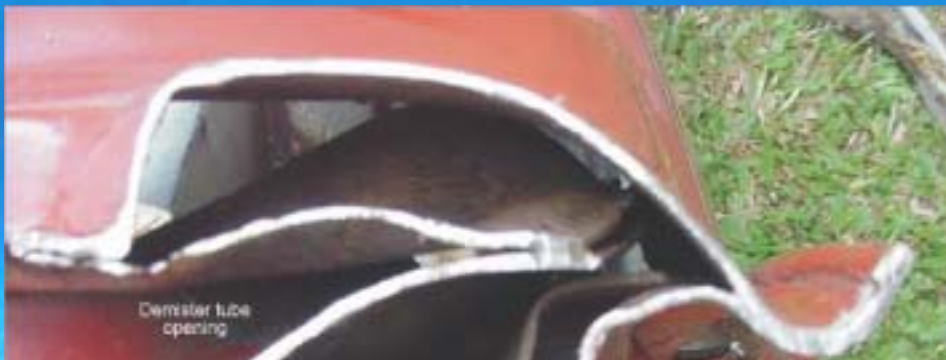
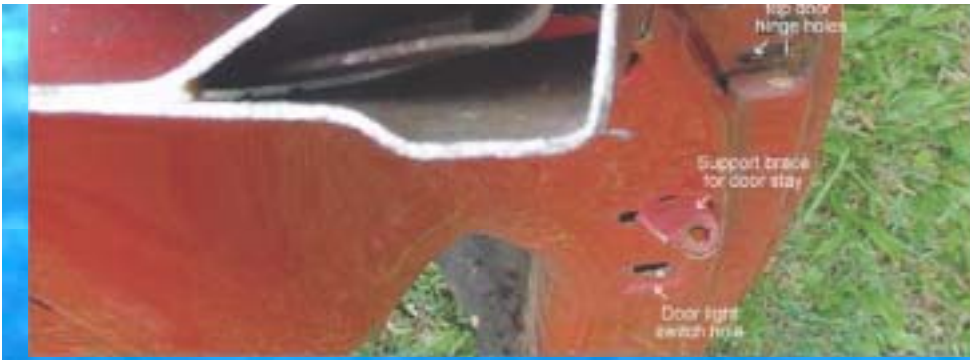
Section through the "A" pillar just above the bottom of the windscreen.
[top of page](#)

Section through the "A" pillar just above the bottom of the windscreen. Note the extra strengthening brace.

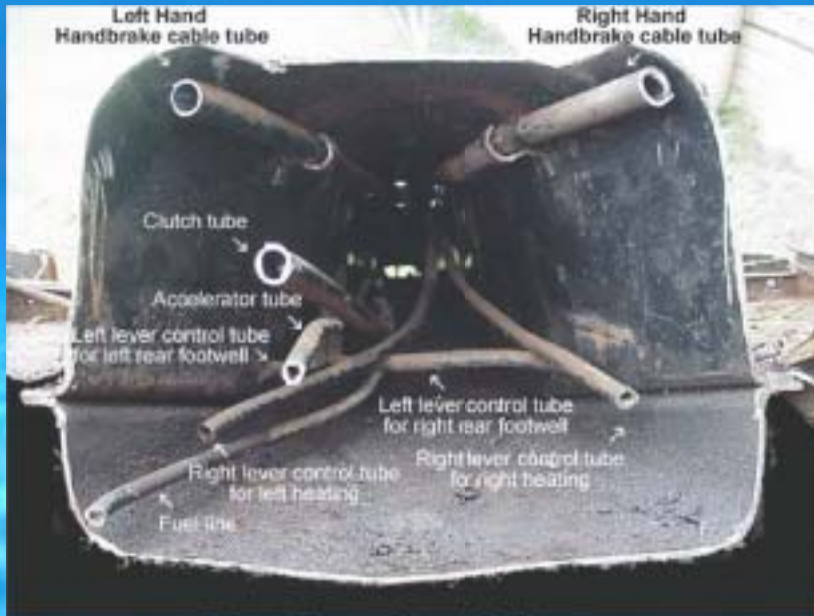
Peering into the tunnel from the rear

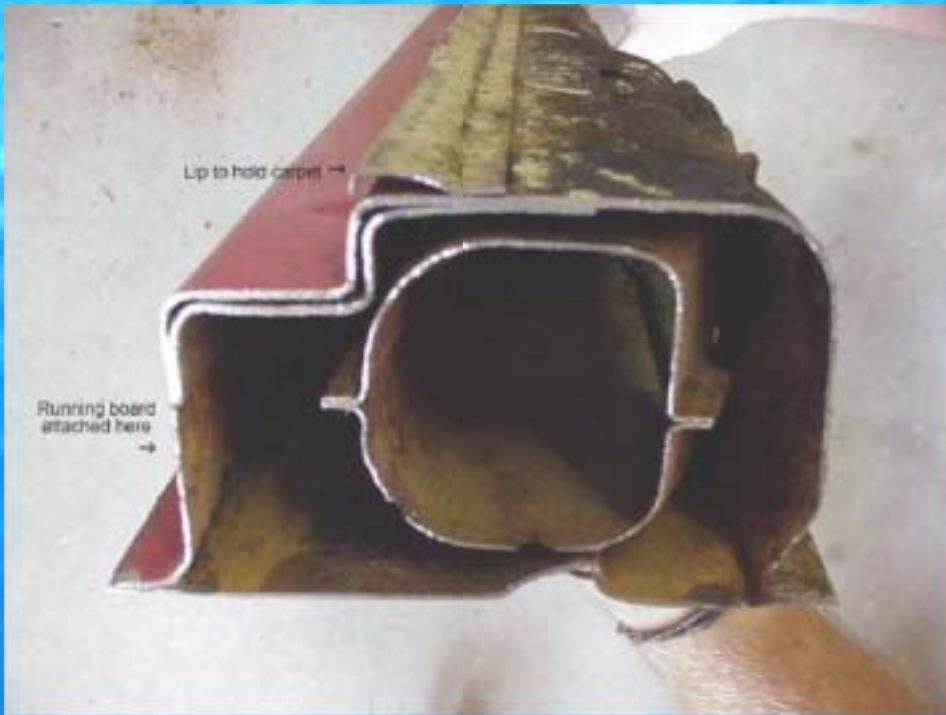
The heater channel.

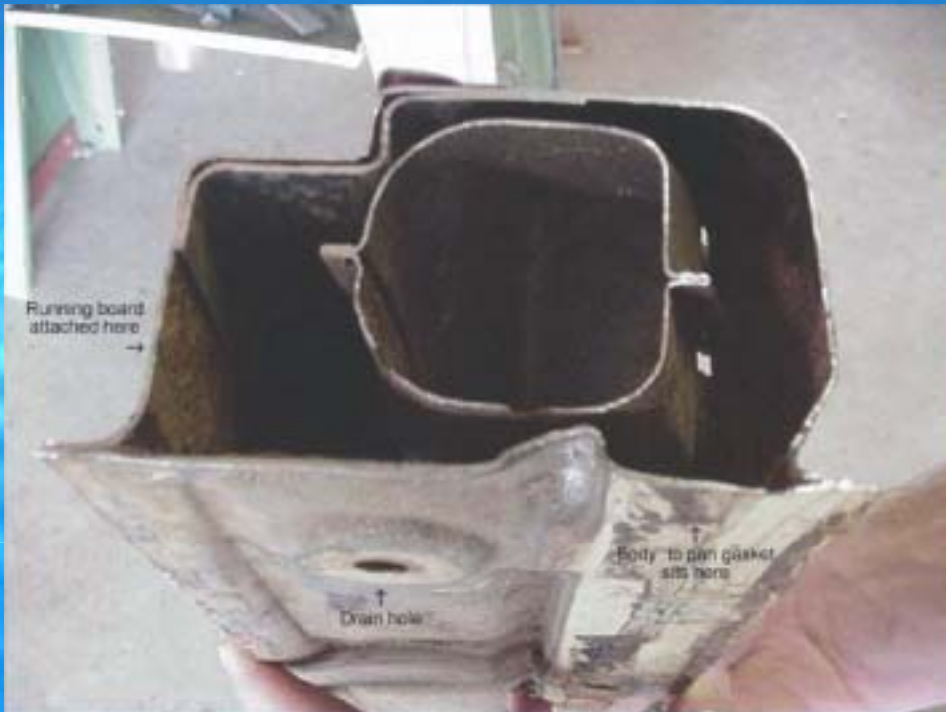
Section through the right hand heater channel.
[top of page](#)

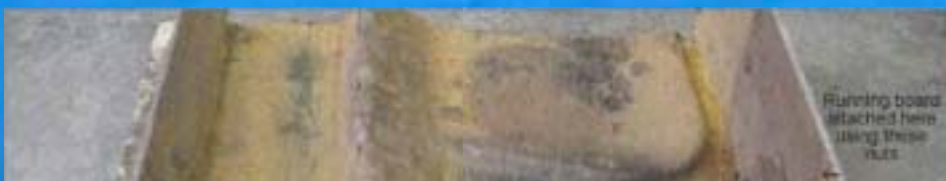
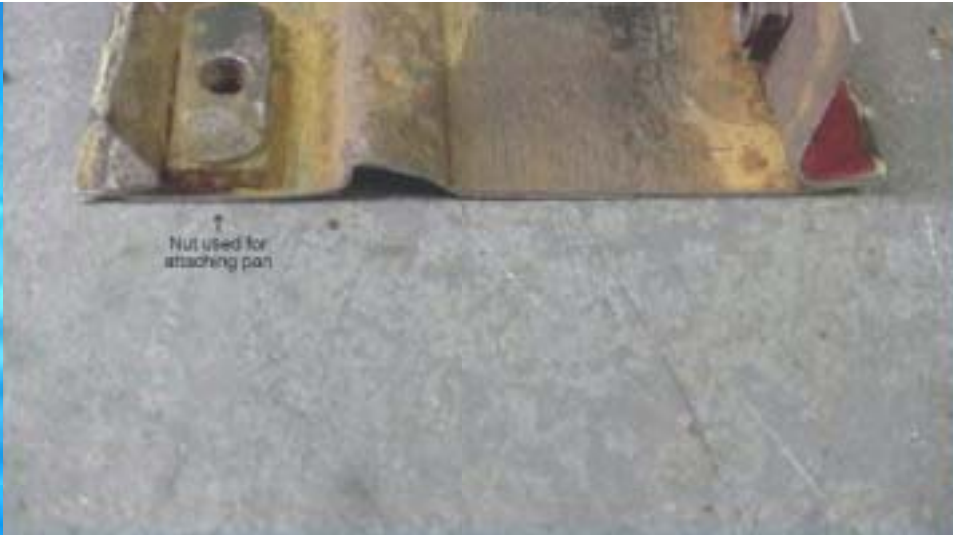
Section through the right hand heater channel.
[top of page](#)

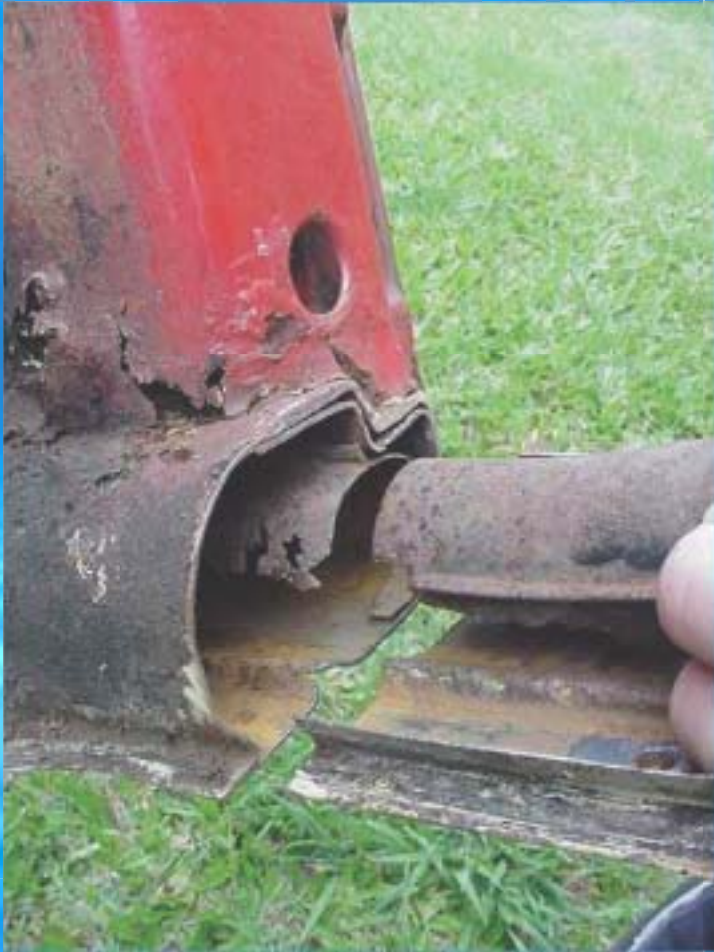
Section through the right hand heater channel the top has also been removed showing the different "nuts" welded to the inside.
[top of page](#)

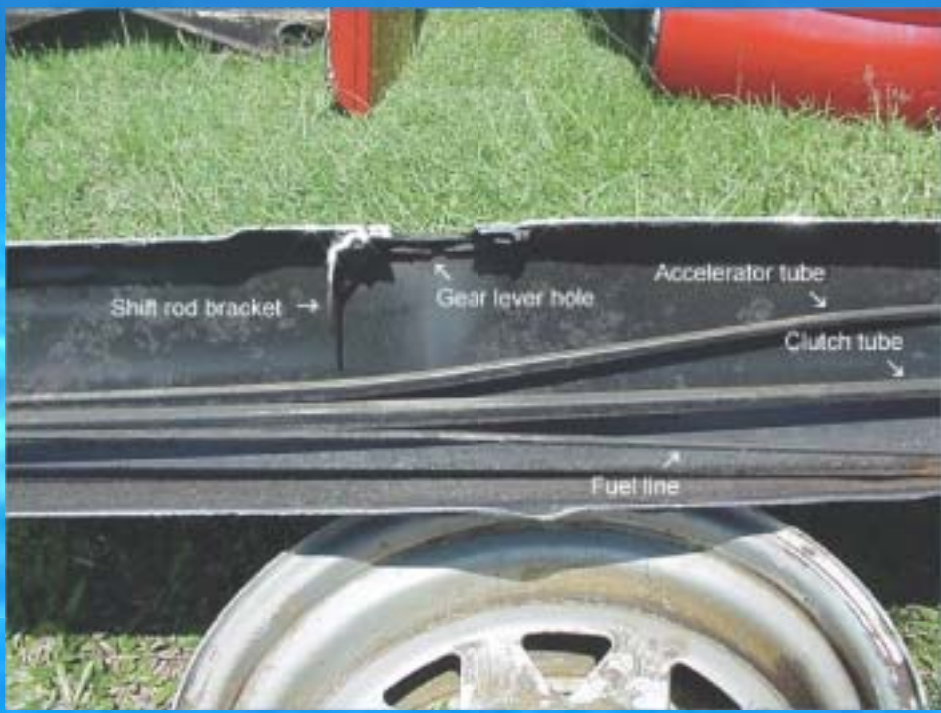
The right hand heater channel where it meets the "A" pillar. The heater duct at this point is socketed into each other (I did not cut the duct at this point). The top of the heater channel on the right of this photo has been removed to expose the heater duct inside.
[top of page](#)

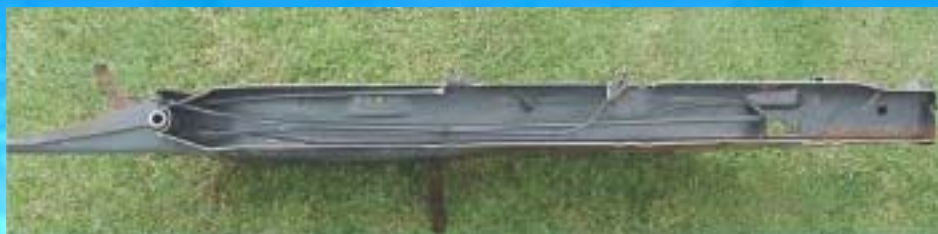
Inside the left hand side of the tunnel - it has been opened length ways through the centre of the tunnel from front to back. Since this photo was taken, I have sectioned the frame fork.
Note- I have divided this photo into eight "hot" sections, as you move your cursor over and click you can get that section in detail, use your browser "back" to return to here.
[top of page](#)

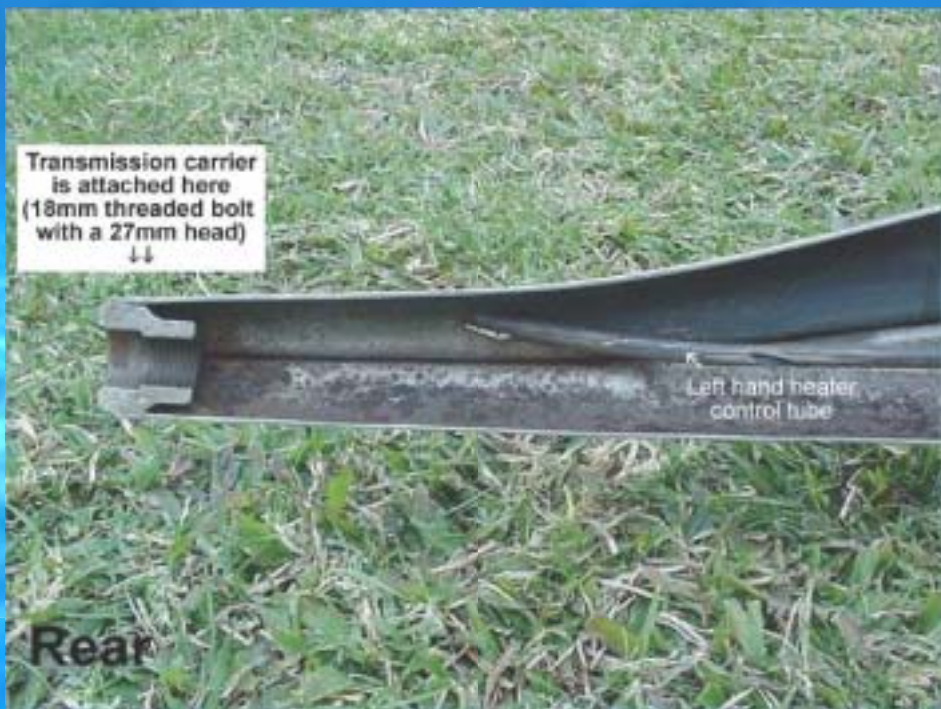
Transmission carrier
is attached here
(18mm threaded bolt
with a 27mm head)
↓↓

Left hand heater
control tube
